# Green Infrastructure Study

## Site Allocation H7b

**Client**  
Basildon Borough  
Council

**Version**  
Final Report

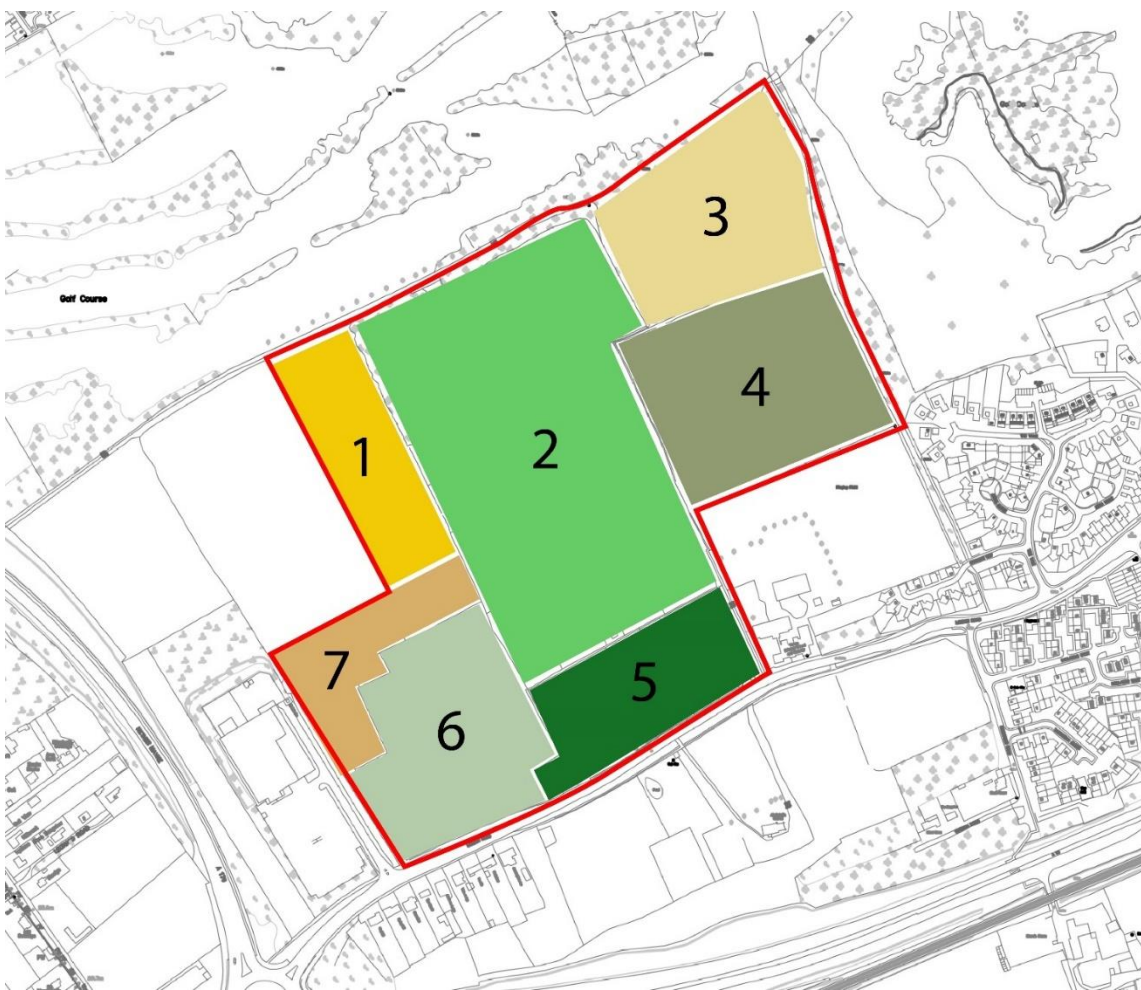
Figure 9: Site-scale Landscape Characterisation of the site allocation (Place Services, 2021)

- 3.3.1 A site-wide assessment of the character of the landscape has been undertaken to inform the Green Infrastructure framework for future development.
- 3.3.2 Field survey work was undertaken in May 2021 to confirm and refine the baseline desk study, recording characteristics that cannot be recorded via the desk study alone, and informing the analysis and assessment. Findings were recorded onto survey sheets and OS mapping.
- 3.3.3 Drawing on the baseline work and a field assessment, a site wide characteristic study has been undertaken.
- 3.3.4 The study divides the site allocation into site-scale landscape parcels. Site H7b has been divided into 7 parcels (Figure 9).
- 3.3.5 For each parcel, there will be a description of the key characteristics and site photographs.

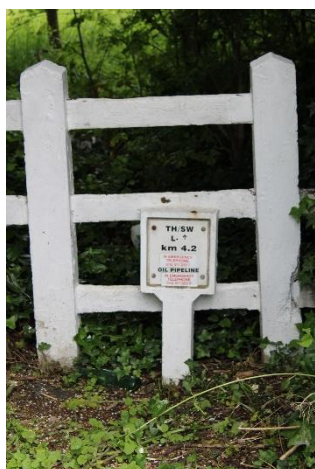
Figure 21: Oil pipeline marker

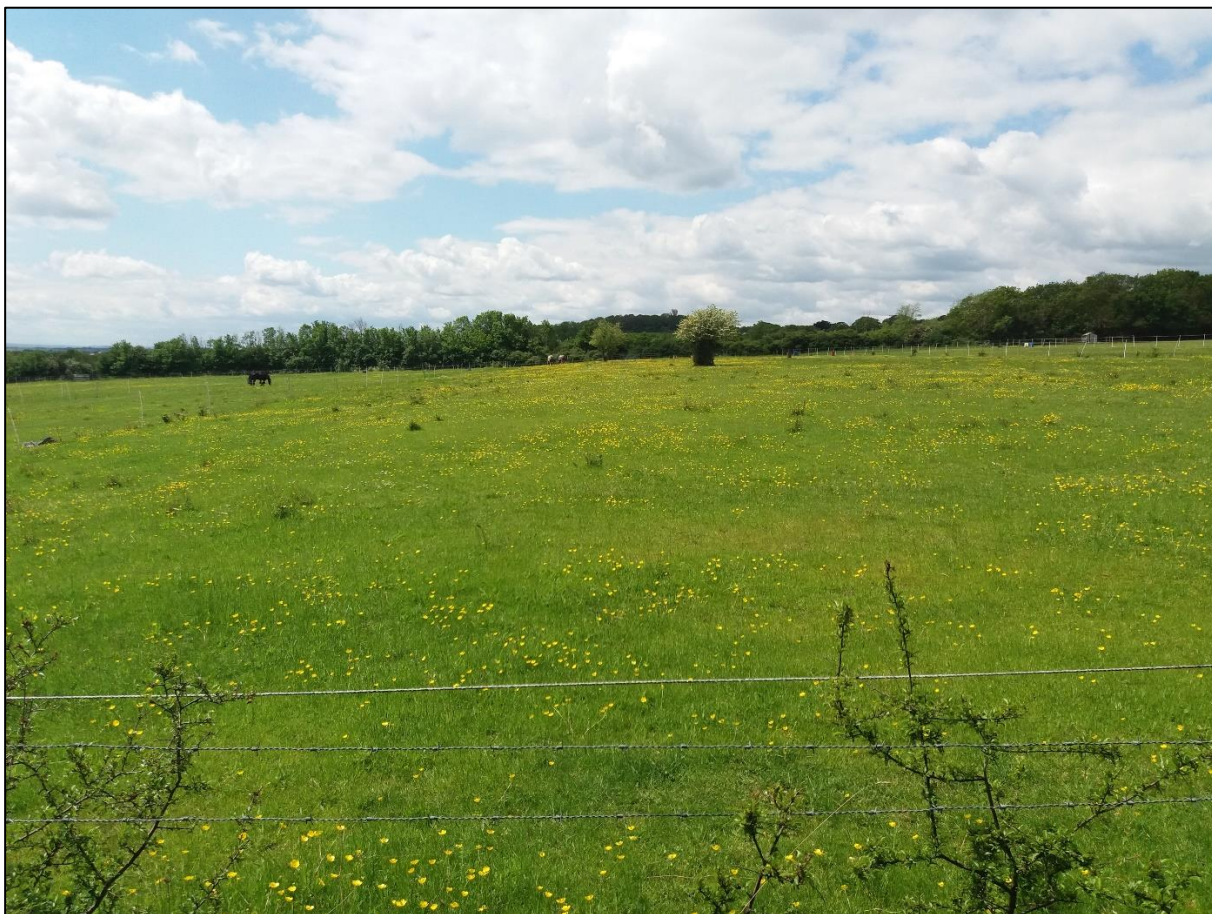
Figure 26 – Looking west across F2

4.3.4 F2 - The largest of the fields, F2 was divided into five strips to the north of an east-west grass track (F2a-d), with a strip to the south of the track (F2e) further subdivided into smaller paddocks. Different sections had been grazed at different intensities or frequencies, with varied sward heights as a result. Young scrub was more prominent towards the top of the slope and in more restricted patches elsewhere.

4.3.5 Overall, F2 was the most diverse of the fields with 46 species recorded (excluding woody species), only five of which, all recorded as 'Rare', are considered undesirable. A few specimens of the Essex Red List species Pale Flax were present. Meadow Buttercup, Common Bird's-foot-trefoil and Creeping Cinquefoil were all prominent throughout, with Wild Carrot, Common Knapweed and Common Cat's-ear 'Frequent' or 'Abundant' in places.

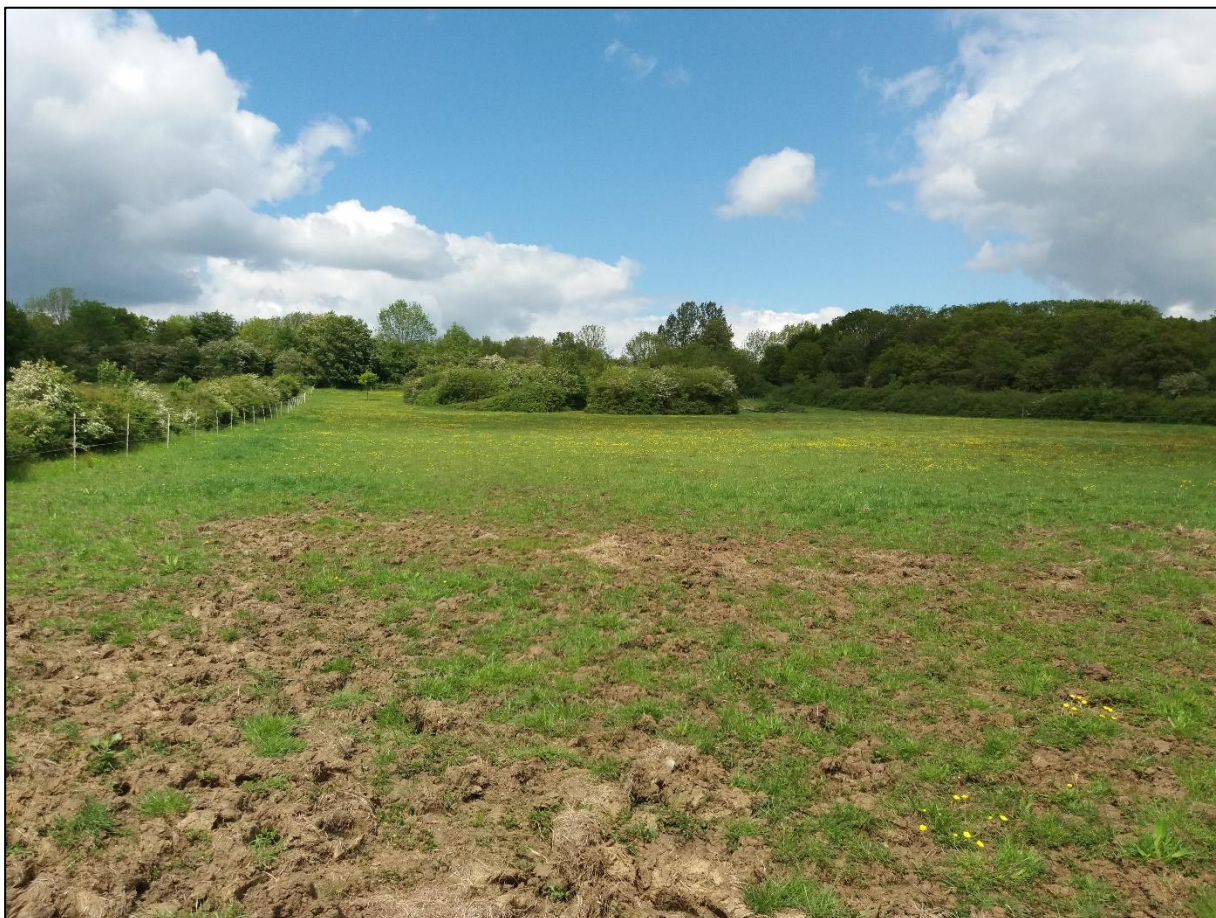
Figure 27 – Looking north across F3, showing heavily poached section

- 4.3.6 F3 - This field forms a relatively narrow north-south strip with a large ring of scrub towards the top of the slope. The southernmost section was fenced off (F3a) and had been heavily grazed and poached, with several patches of obvious nutrient enrichment visible. Just to the north of the fenced-off section, was a similarly sized area that had been very heavily poached (F3c), such that the sward was fragmented and the ground surface was very uneven. The remainder of the field (F3b) showed some signs of poaching but had not been grazed in the immediate past. Young scrub was abundant, especially lower down the slope.

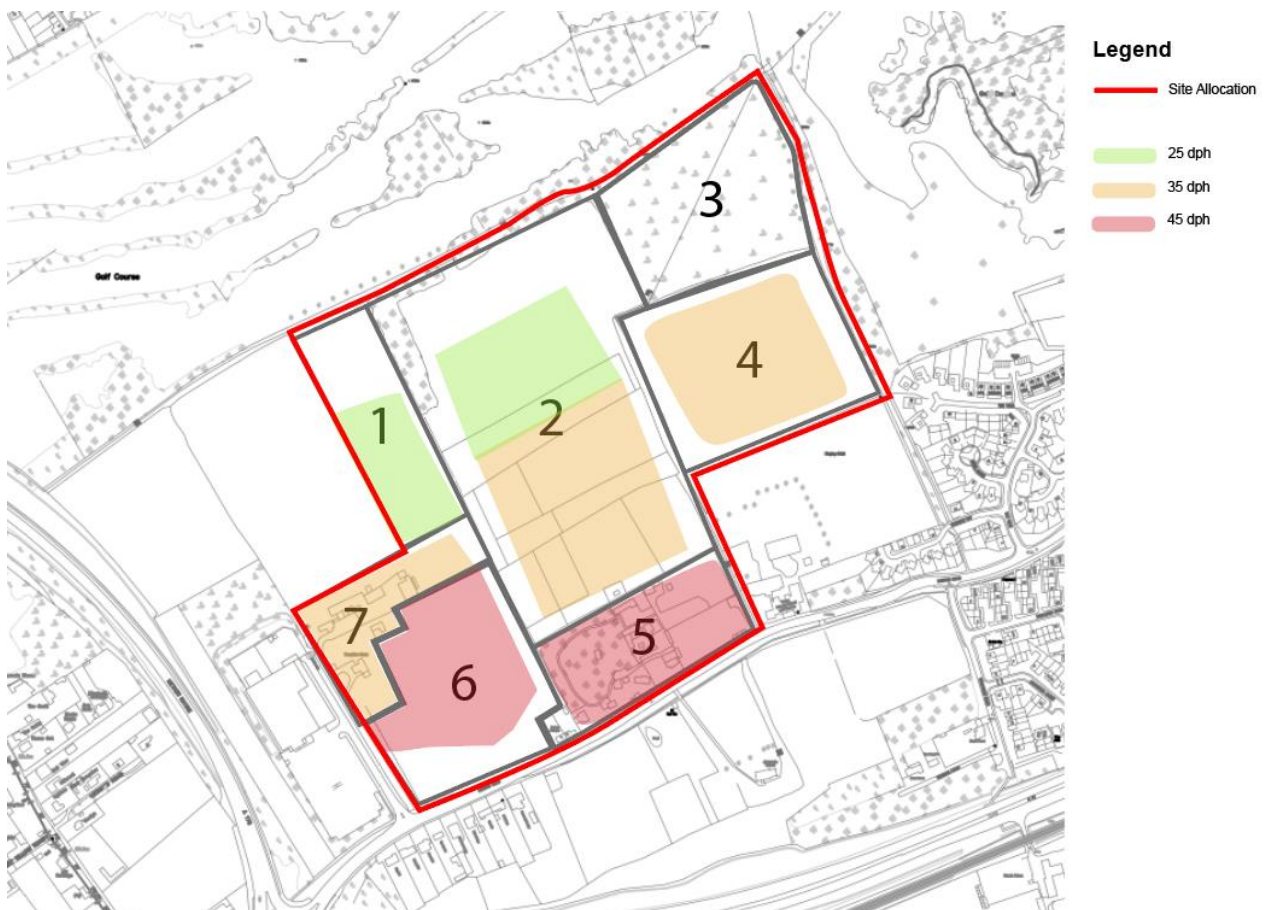
Figure 29: Potential housing density plan

- 6.1 Calculations have been undertaken to understand if the policy requirement of 615 homes under Policy H7 can be physically accommodated on site using the indicative development scenario included in the Green Infrastructure Framework Plan.
- 6.2 Using the 7 parcels identified in Figure 29, the table below (Table 3: Land Use Budget) illustrate the number of units that could be achieved based on the Gross Developable area of each parcel.
- 6.3 Based on these findings, it is estimated that 391 units could be achieved using the densities set out in Figure 29. This is 224 units short of the requirements under Policy H7.

- 8.4 Whilst allowing capacity for the recommended 50metre landscape buffer on the northern corridor and suitable landscape corridors along existing hedgerows and road boundaries, it is estimated that 391 units could be achieved, which is 224 units short of the requirements under Policy H7.
